## Road Safety Audit Report

**M-35 FROM FORD RIVER BRIDGE TO LAKE SHORE DRIVE**

CS 21031 - JN 203002 EPE

January 2020

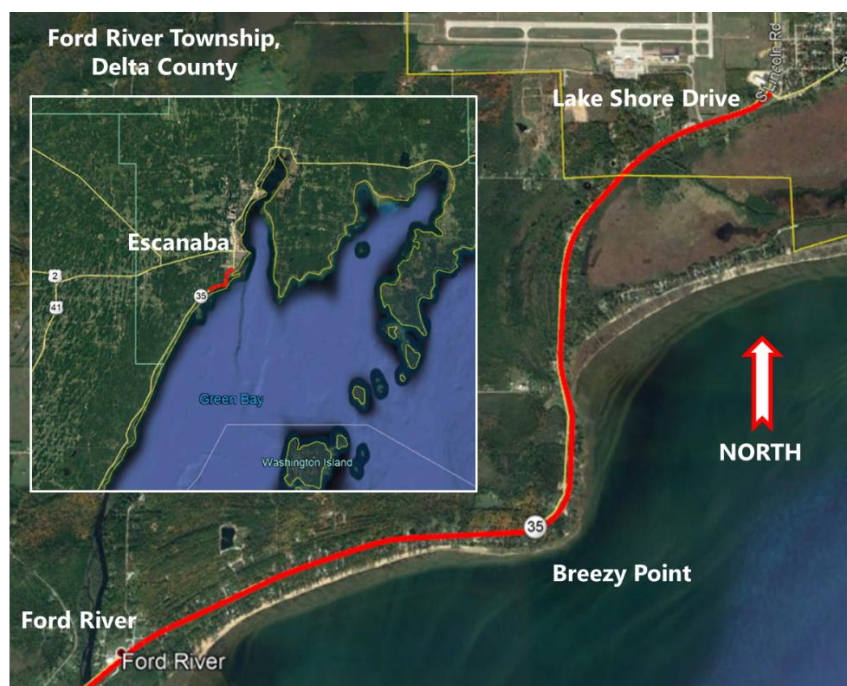
Figure 1: RSA Study Area

This RSA was performed in the City of Escanaba and Ford River Township, Delta County, Michigan on November 6<sup>th</sup> and 7<sup>th</sup>, 2019 for the existing M-35 roadway segment from the Ford River bridge to Lake Shore Drive. The RSA study area also included the local road intersections and key access points within these limits. The project location is depicted on the aerial shown on Figure 1. The RSA was conducted in a manner consistent with the Federal Highway Administration (FHWA) *Road Safety Audit Guidelines* adopted by the Michigan Department of Transportation (MDOT).

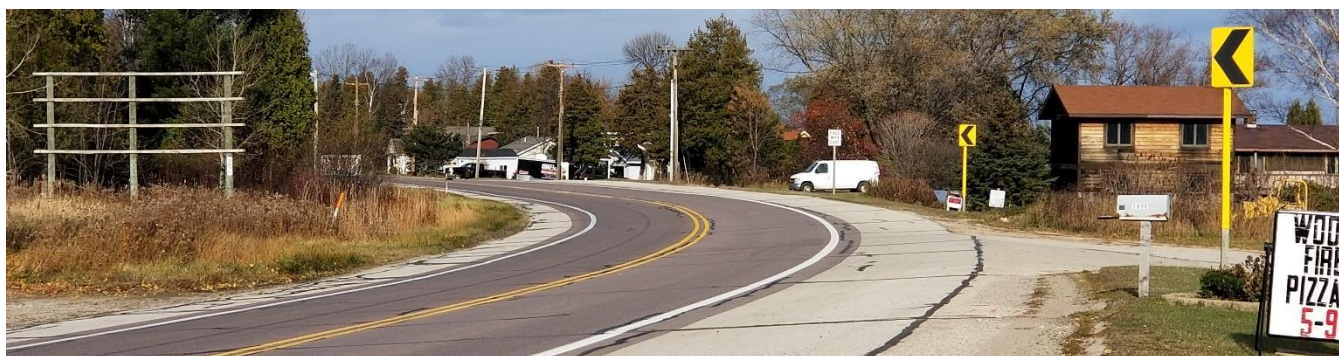
*Figure 3: Horizontal Curve at Breezy Point*

Despite the degree of horizontal curvature on this route, sightlines along M-35 appear to be generally adequate and appropriate to posted speeds. Particular issues related to intersection sight distance are noted in the RSA findings that follow. Superelevation at the Lake Shore Drive and Breezy point horizontal curves is noticeable from both a visual and driver comfort perspective. Traffic control signs and markings on the route are generally appropriate and visible. Reflectors, vertical reflective panels, and chevrons provide positive delineation for horizontal curves and other warning signs. Lighting along the corridor is regularly spaced on the north end, with all intersections lit overhead.

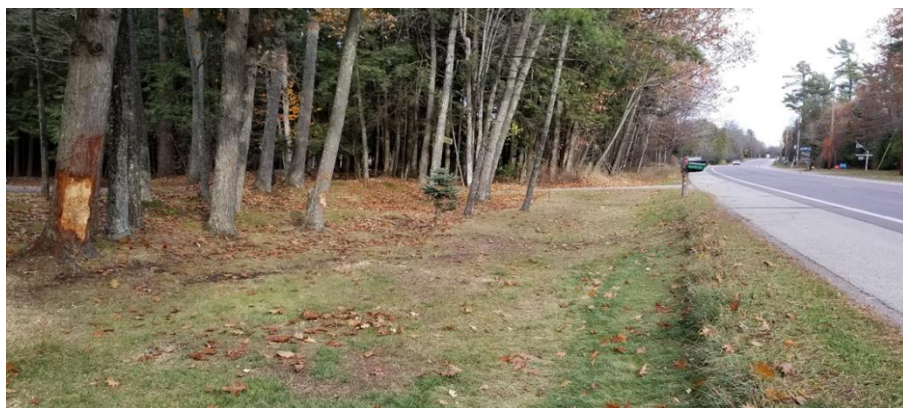
*Figure 6: Tree Struck by Vehicle*

**Observations:** Overall, roadside slopes are generally recoverable within the study limits. However, this route is lined with trees, utility poles, mailboxes, and signs which are sometimes within the clear zone. Steeper slopes exist at spots along the shoreline, and a drop-off from the shoulder was noted on the north side of M-35 through the residential cottage area. Lane and shoulder widths are appropriate, with 12-foot lanes and 8-foot shoulders. The paved shoulders provide width for recovery for outside lane departures; however, M-35 lacks both centerline and shoulder corrugations throughout the limits of this RSA. Two locations were noted where trees had clearly been struck:

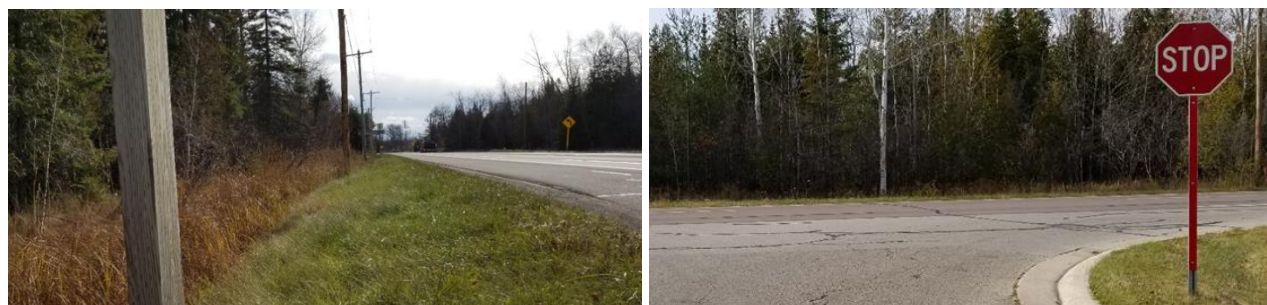
Figure 7: Utility Poles (left) and Minor Approach (right)

**Risk Analysis:** Lack of sight distance at intersections can lead to angle crashes, which at high speeds can result in severe outcome. Failure to stop at minor approaches can also result in angle crashes with high-speed opposing traffic, or single vehicle roadway departure crashes. M-35 traffic may also experience rear-end or sideswipe crashes related to slowing and turning, particularly when approaching intersections are not conspicuous, leading to rapid braking. Concerns noted by the RSA Team related to specific study area intersections are outlined by location in the subsequent sections of this report.

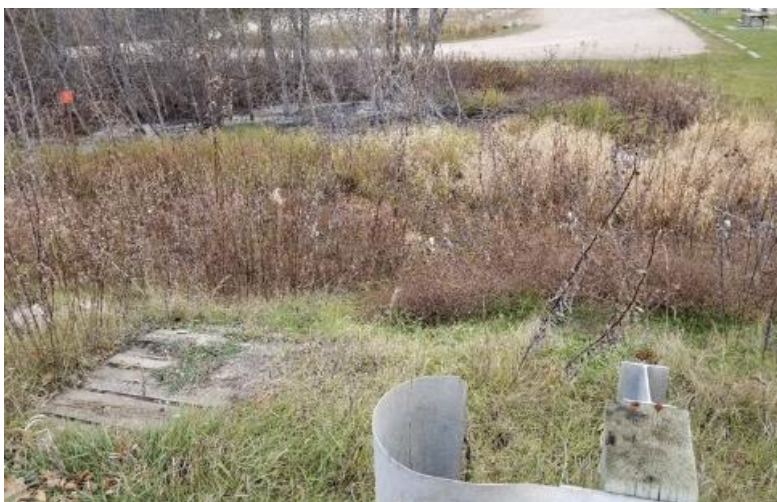
*Figure 8: Pedestrian Connection at Ford River Boat Launch*

**Observations:** The Ford River Bridge, located at the western end of the study area, has a pedestrian walkway on the south side of the bridge. This walkway is separated from vehicular traffic by a concrete barricade, but does not connect directly to any other facility on either end of the bridge. There are signs of pedestrian activity, including a partially worn path leading from the bridge to the Ford River Boat Launch, worn wooden stairs connecting elevations between the bridge and the boat launch, and remnants of fishing supplies. Regardless of any restrictions on fishing from the bridge deck that may exist, fishing appears to occur off the southwest corner of the structure, to which the bridge provides connection from the boat launch.

A pedestrian connection between the bridge and the boat launch on the east side of the river passes over an apparent low marshy area and is likely impassable in wet conditions. In order to walk between the boat launch and the bridge, pedestrians would have to walk along the shoulder of M-35 until reaching the guardrail. Side slopes are difficult to traverse by foot, so pedestrians are likely to walk in front of the guardrail as well.

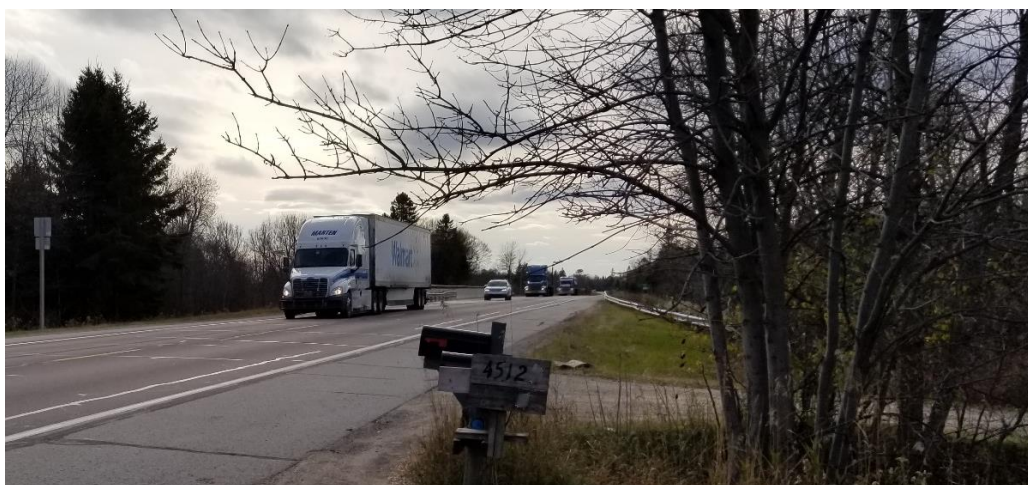
*Figure 9: Sight Distance over Ford River Bridge*

**Observations:** Sight distance is moderately limited when exiting the Ford River Boat Launch, especially looking to the southwest over the Ford River bridge. The RSA Team observations were made from a large van, with a driver eye height that is expected to be similar to vehicles that may be towing a trailer / boat. From this height, the bridge, guard rail, and barrier were not seen to be a significant obstruction; however, passenger vehicle sight distance would not extend beyond the bridge as clearly. The vertical profile was observed to more significantly impact sight distance than vegetation; however the tree line and brush do block the driver's view, depending where on the minor approach a vehicle is stopped.

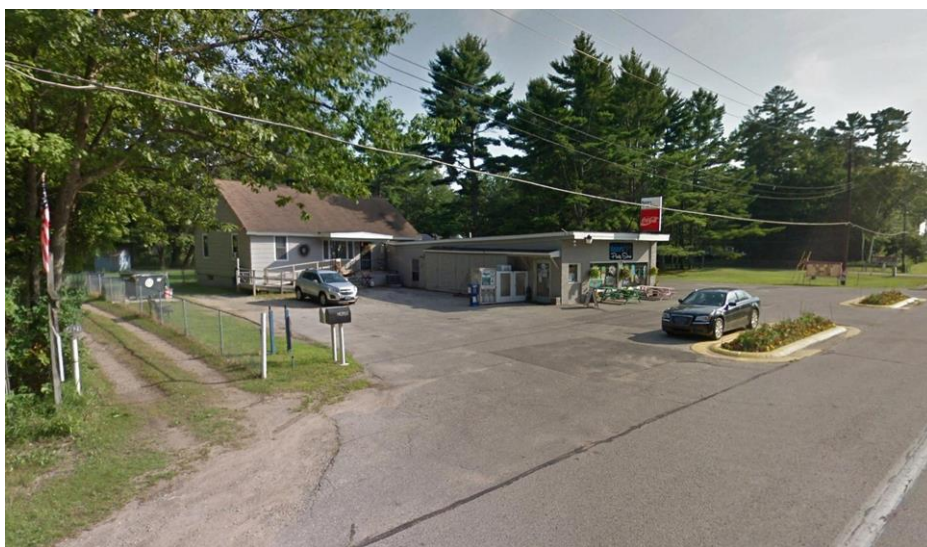
*Figure 11: Meister's Party Store Access*

1. **Consolidate Access:** Close one access point and create more defined access for the other two in order to improve ingress, egress, site circulation, and parking. The middle access point appears to be a candidate for closure; whereby the curbed islands can be linked together to improve access control, and a directional circulation pattern may be created.

**Priority for Consideration:** Moderate

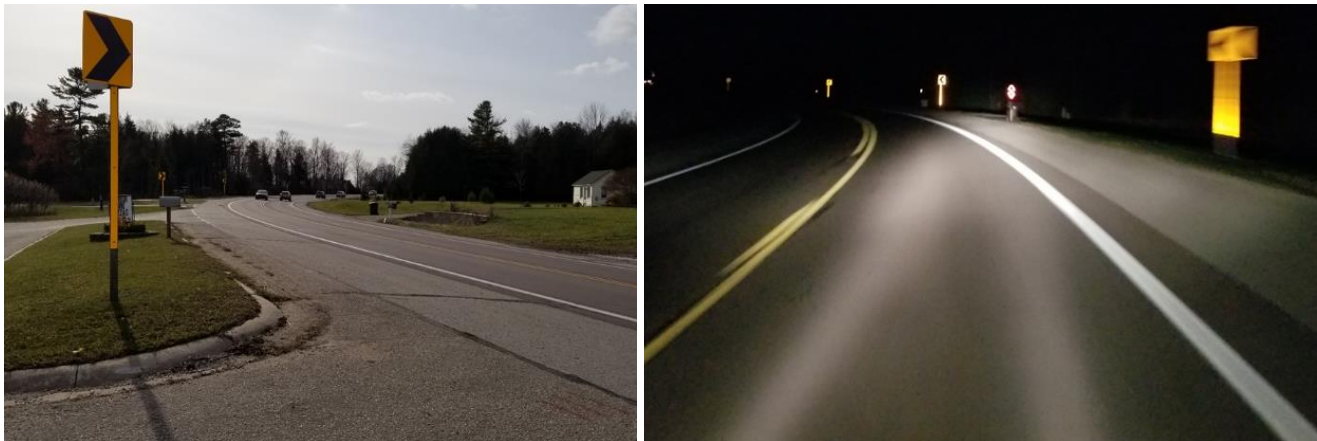
*Figure 12: Chevrons on the Breezy Point Curve*

**Observations:** The horizontal curve at Breezy Point was observed by the RSA Team to drive comfortably at or slightly above the posted 50 mph speed, even in a large van. The designed curve radius and superelevation seemed appropriate to maintain travel speed within the travel lane. Large trucks were regularly observed navigating this curve at apparent posted speeds as well. cursory review of curve geometrics indicates the geometrics are appropriate for a 50 to 60 mph design speed.

The RSA Team observed positive signing relative to this horizontal curve. Curve warning signs are appropriately posted and visibility and curve navigation were enhanced by posted chevrons with vertical reflective panels on each chevron sign post. The RSA Team agreed that 1-2 additional chevrons should be installed at the north end of this curve.

**Risk Analysis:** Lane departure can occur through horizontal curves, which can lead to single vehicle crashes. Review of crash history indicates that lane departure crashes on M-35 typically result in PDO severity; however also create some risk for A-level injury or fatal severity due to overturn or head-on crash occurrence. Risk of lane departure is higher during adverse weather conditions.

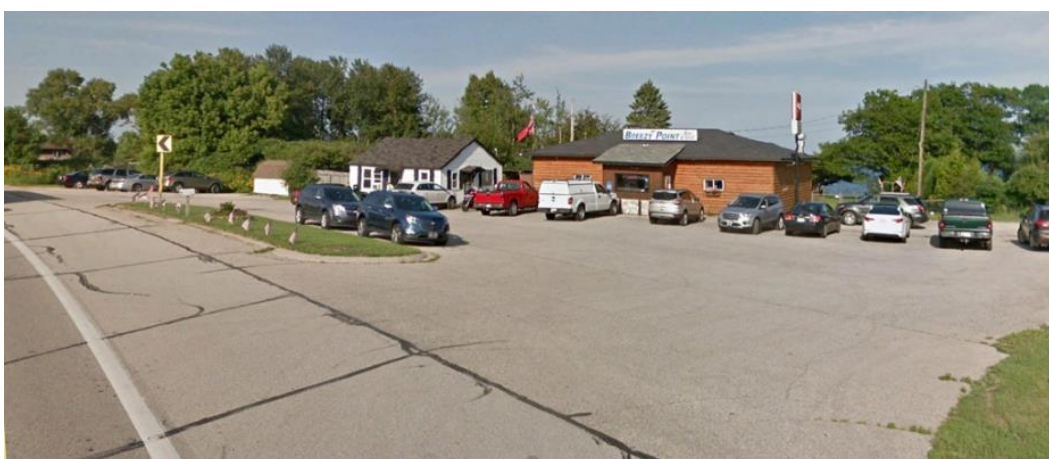
*Figure 13: Breezy Point Bar Access*

The bar / restaurant has two access points that are separated by a curbed island that is set back from the normal shoulder width, creating large paved areas between the travelled way and the parking area. These driveways are wide, and generally uncontrolled, particularly at the north access. At this location, the paved area appears to have been widened north of the original driveway approach. Additionally, there is evidence that parking is encroaching on the dirt / gravel area to the north, which has caused pavement edge deterioration and drop off.

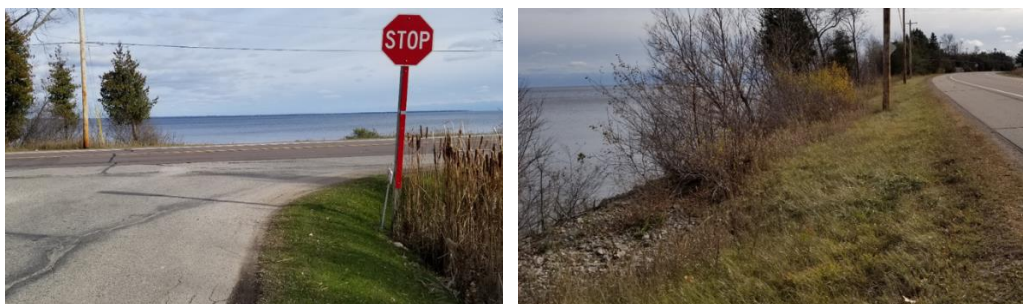
**Observations:** The intersection of M-35 and 11<sup>th</sup> Road is a “T” intersection, where 11<sup>th</sup> Road intersects M-35 at a slightly less than perpendicular angle. The minor approach looks out into Little Bay de Noc, and the RSA Team noted a potential infinity effect; whereby the driver cannot distinguish between the end of the road and the start of the water, particularly at night. The shoreline is closest to M-35 at this location as compared to the rest of the study area. There is limited vegetation on the roadside, therefore providing no visual queues from the minor approach.

*Figure 14: Infinity Effect (left) and Roadside Slope (right)*

1. **Enhance Signs & Markings:** Install a STOP bar and W1-7 bi-directional arrow sign on and opposing the minor road approach. The RSA Team concurred that this location is the highest priority for such treatment, relative to all minor approaches in the study area.
2. **Install Guard Rail:** In order to prevent vehicles from departing the roadway into the shoreline, install guardrail on the outside of this horizontal curve. This treatment would also restrict undesirable standing / parking on this shoulder.
3. **Enclose Drainage:** Enclosing drainage on the SW quadrant would improve roadside recovery; however noting that the existing culvert end treatments are not blunt and reasonably forgiving.

**Priority for Consideration:** Low

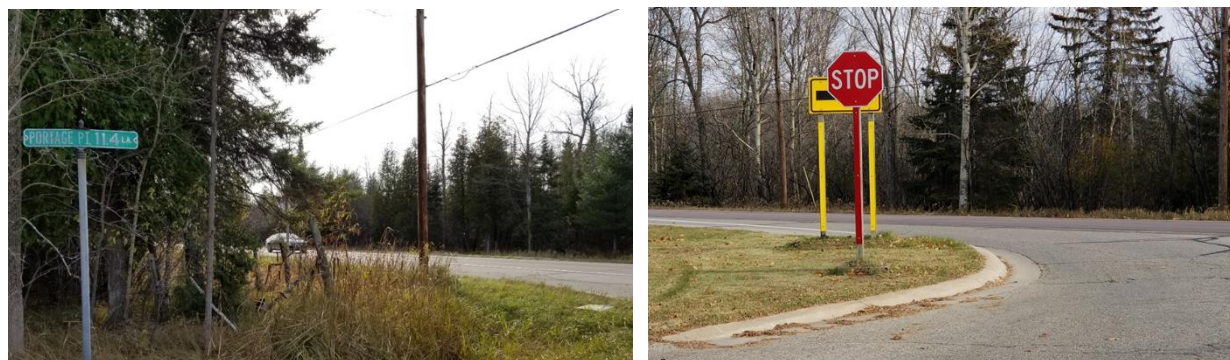
Figure 15: Limited Sight Distance (left) and Conflicting Signs (right)

**Observations:** The intersections of M-35 with Portage Point Lane and 12<sup>th</sup> Road both have considerable intersection sight distance obstructions and visibility concerns relative to the minor approaches. At Portage Point Lane, sightline obstruction to the south was particularly noted on the SE quadrant due to the utility poles, trees, and brush.

2. **Relocate Signs:** Relocate the W1-6 directional arrow sign to a more visible location.  
*Note: The RSA Team also observed that this is the only minor approach with a supplemental left-side STOP sign in the study area. While this is generally viewed as a positive safety treatment, this STOP sign is redundant with respect to the W1-6 sign for the purpose of improving intersection conspicuity. Therefore, consider replacing this supplemental sign with a STOP AHEAD sign further upstream on the minor approach. As the turned-in alignment may restrict sight of the standard right-side STOP sign, an upstream warning would improve driver awareness on approach to M-35.*

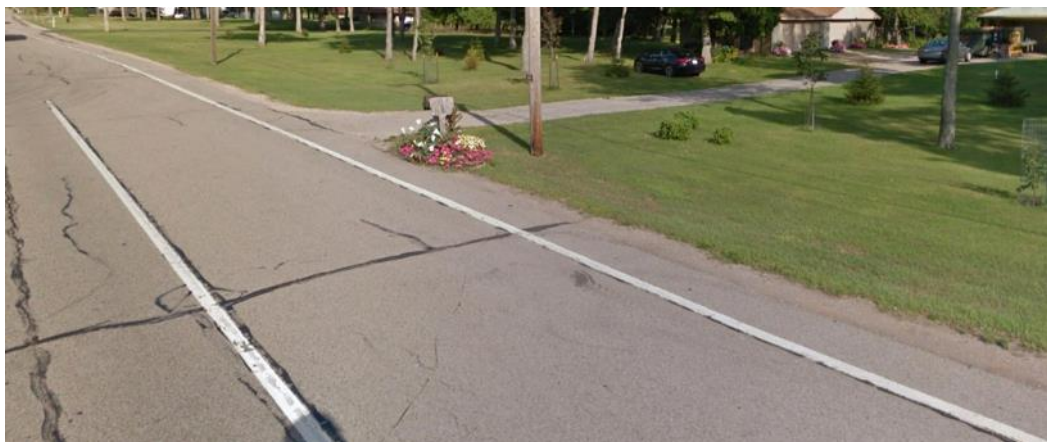
Figure 16: Passing Flare at Airport Road

1. **Extend Pathway:** There is existing sidewalk / path on both sides of M-35, approximately 1,000 feet north of this intersection. These non-motorized facilities could be extended to the south through this intersection to eliminate conflicts within the shoulder area.  
*Note: The extended sidewalk / path can be transitioned back into the paved shoulder to the southwest of Airport Road, similar to the existing transition to the northeast.*
2. **Improve Turn Lanes:** Construct full-width turn lanes and provide appropriate tapers, storage, and paved shoulders.  
*Note: The RSA Team discussed the potential merits of extending the four-lane section from the north through this intersection. Such improvement was determined by consensus to not provide a direct operational or safety benefit for this location and condition.*

**Priority for Consideration:** Low

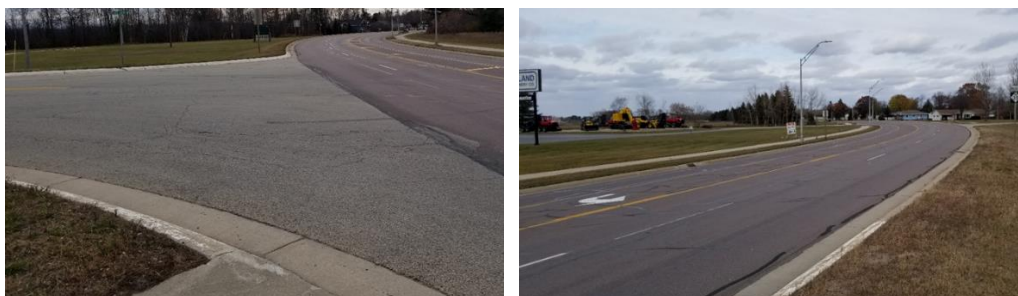
Figure 18: Wide Approach / Radii (left) and Curbed Section (right)

1. **Install Pavement Markings:** Delineating separate left-turn and right-turn lanes would reduce driver conflict and the risk of sideswipe crashes.
2. **Narrow Minor Approach:** Reducing the paved minor approach width and corner radii would further reduce exposure to sideswipe crashes and limit sightline blockages.
3. **Reconstruct Curb:** Roadway rehab / reconstruct may require drainage modifications, shoulder provision, or design exception. Speeds through this area should be monitored for design.

**Priority for Consideration:** Low

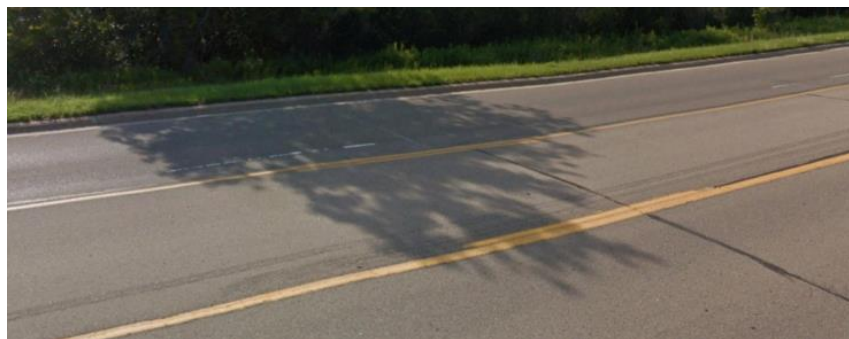
*Figure 19: Conflicting Pavement Markings*

2. **Evaluate Passing Lanes:** Conduct a review of crash history, speeds, and passing maneuvers south of the RSA limits and evaluate MDOT guidance of passing lane criteria.

**Priority for Consideration:** High

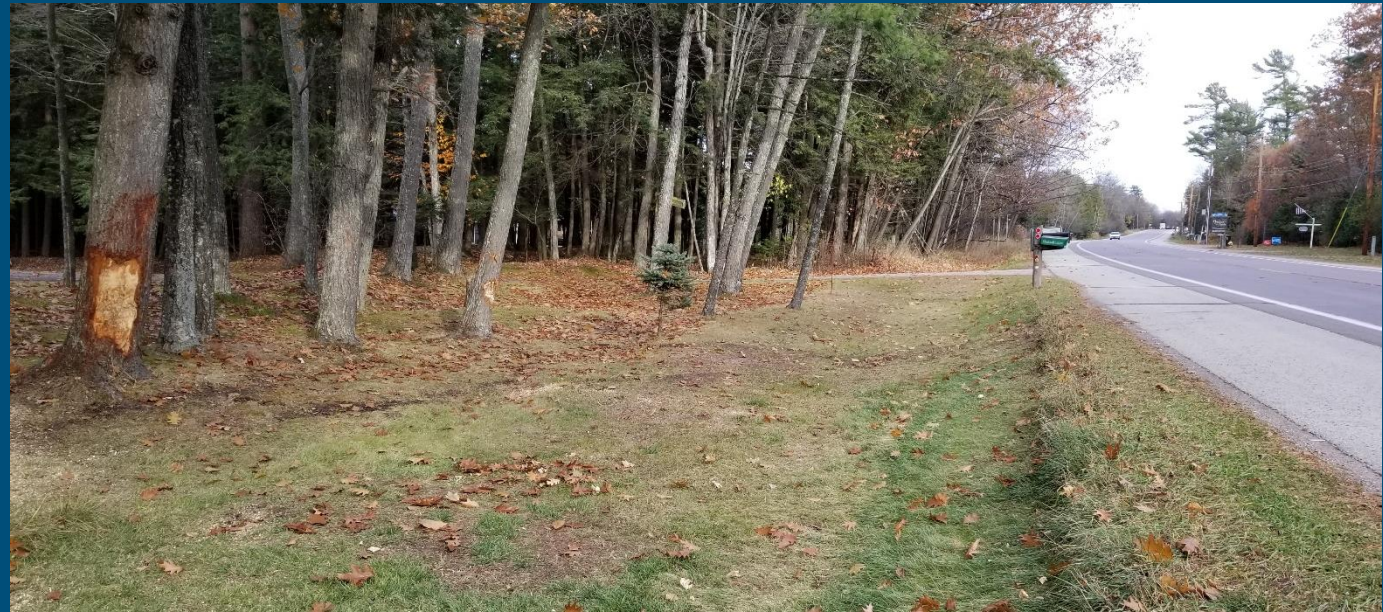
- Severe outcomes have resulted from roadway departure (fixed object and overturn)
- Crash history indicates several drivers fell asleep

- Install shoulder / centerline corrugations

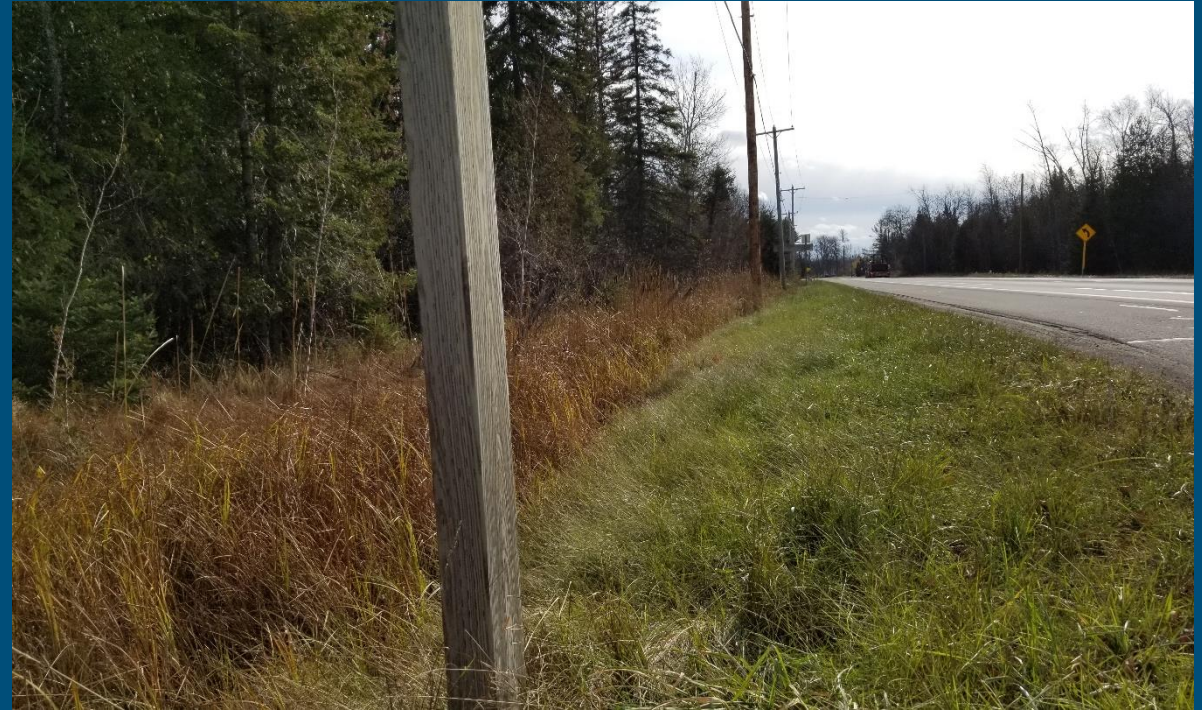
- Fixed object crashes
- Angle crashes at intersections

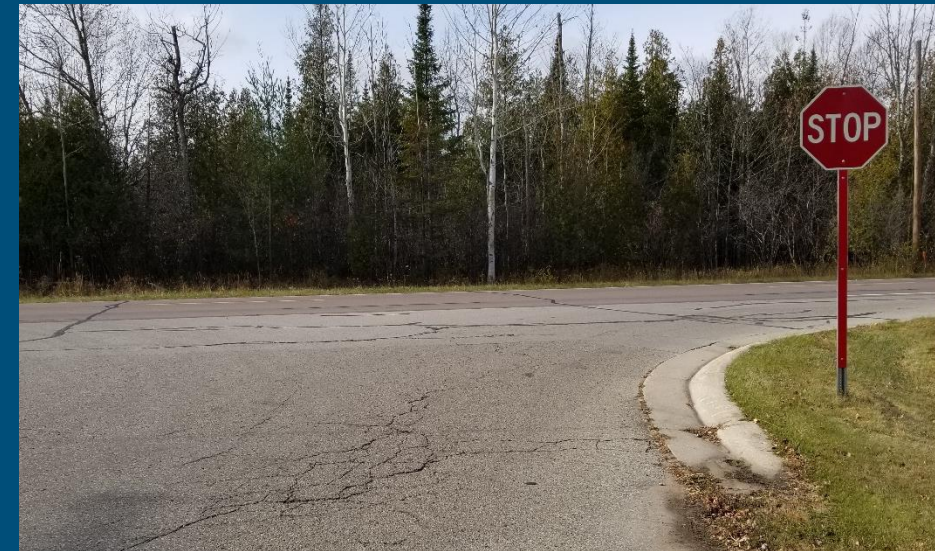
- Failure to stop resulting in roadway departure
- Angle crashes at high speed related to intersection conspicuity
- Rear-end / sideswipe related to slowing / turning

- Install improvements on minor approaches
- Replace aged street signs
- Advanced guide / warning signs

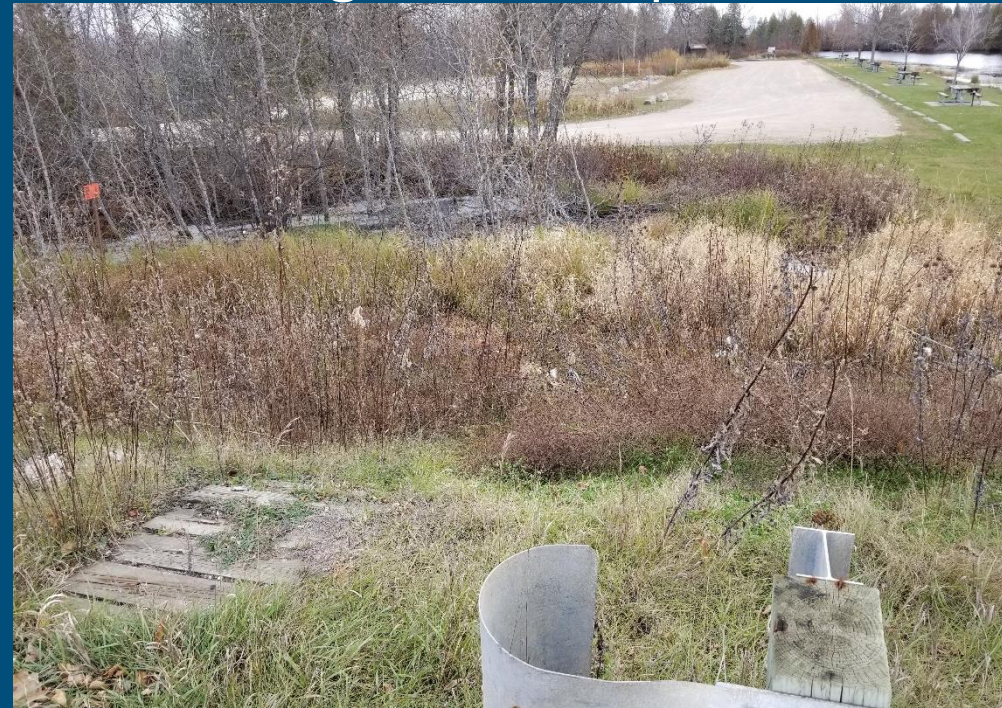
- Bridge has pedestrian access on S side, but no connections to anything
- Some worn path behind guardrail or use shoulder in front of guardrail
- Wooden stairs leading down to marina are overgrown and path is flooded

- Improve pedestrian connection directly to marina area
- Would likely require some fill and a cross culvert

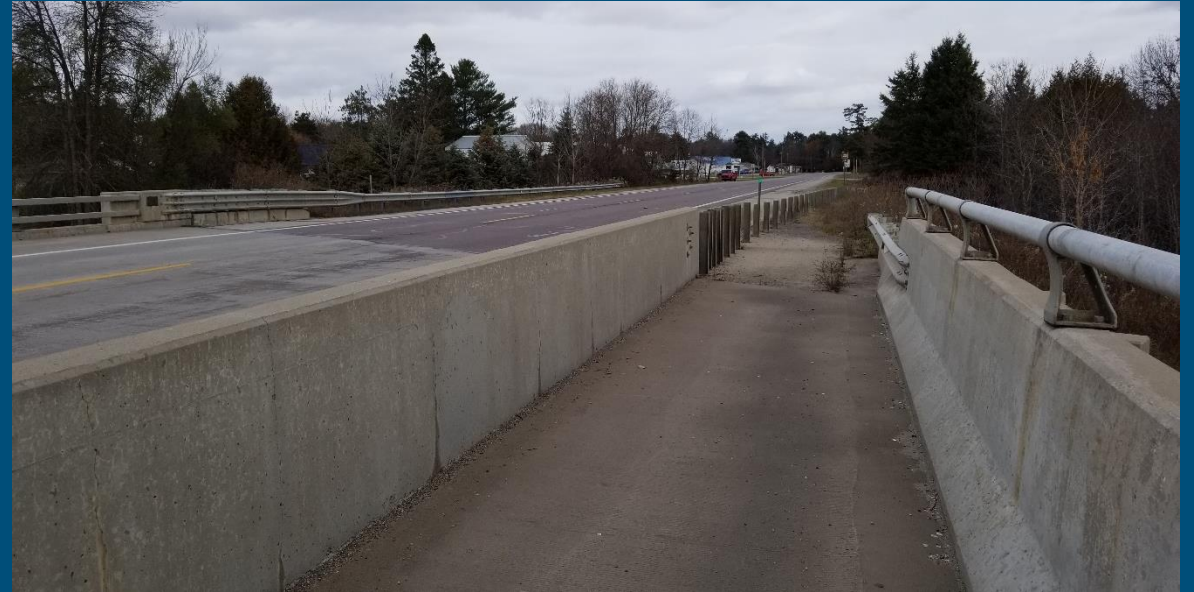
- Angle crashes trying to pull out onto M-35
- Boat trailers slower and exposed for a longer period

- If road is reconstructed, revisit the vertical profile / sight distance
- Move boat access to the east and head-up with Ford River Grill access & 9.9 Lane

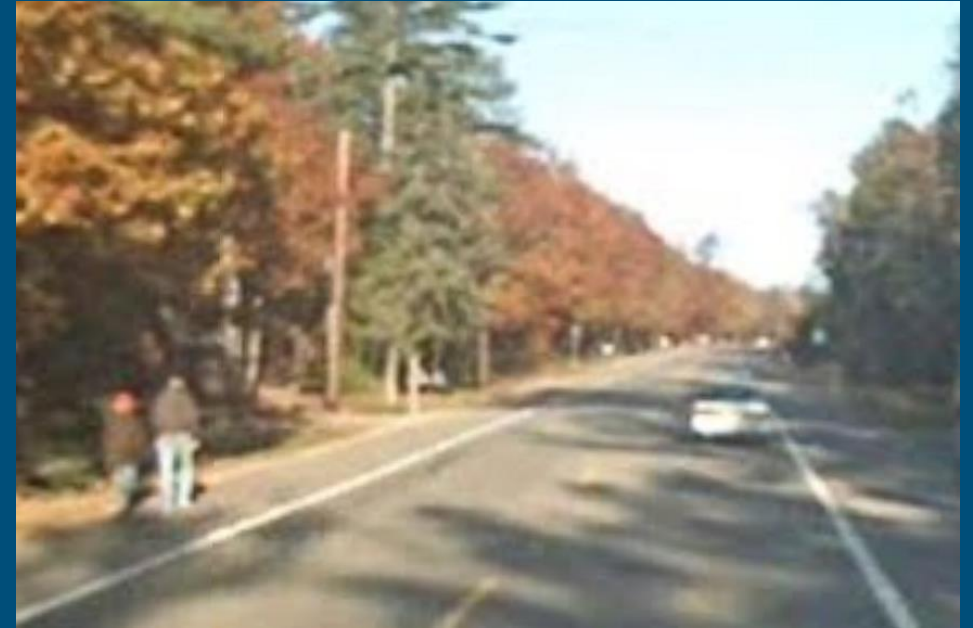
- With a center lane the road would feel even faster, to which traffic appears to be already moving above posted 50 mph (speed control has also been noted as a local concern)

- Further study / observe locations of pedestrian activity (RSA limited observation due to season)
- Reconstruct / widen to provide a continuous center lane for left turns
- Consider narrower shoulders, replace pedestrian accommodation via separate shared use path.
- [discussion of left turn conflicts in center left, low frequency, but potential]

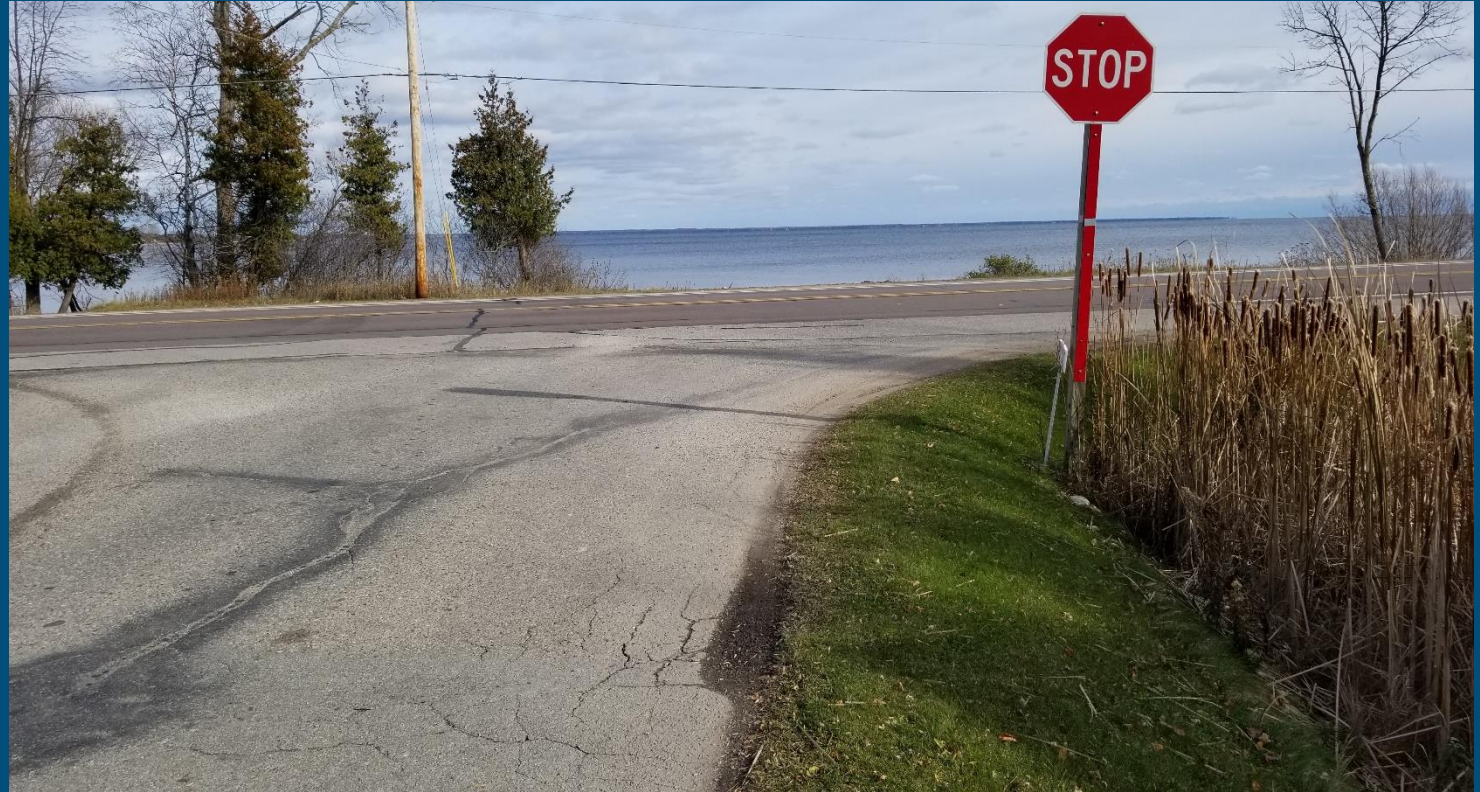
- Minor approach driver may fail to stop

- Install T-intersection arrow sign (W1-7) on bay side facing minor approach

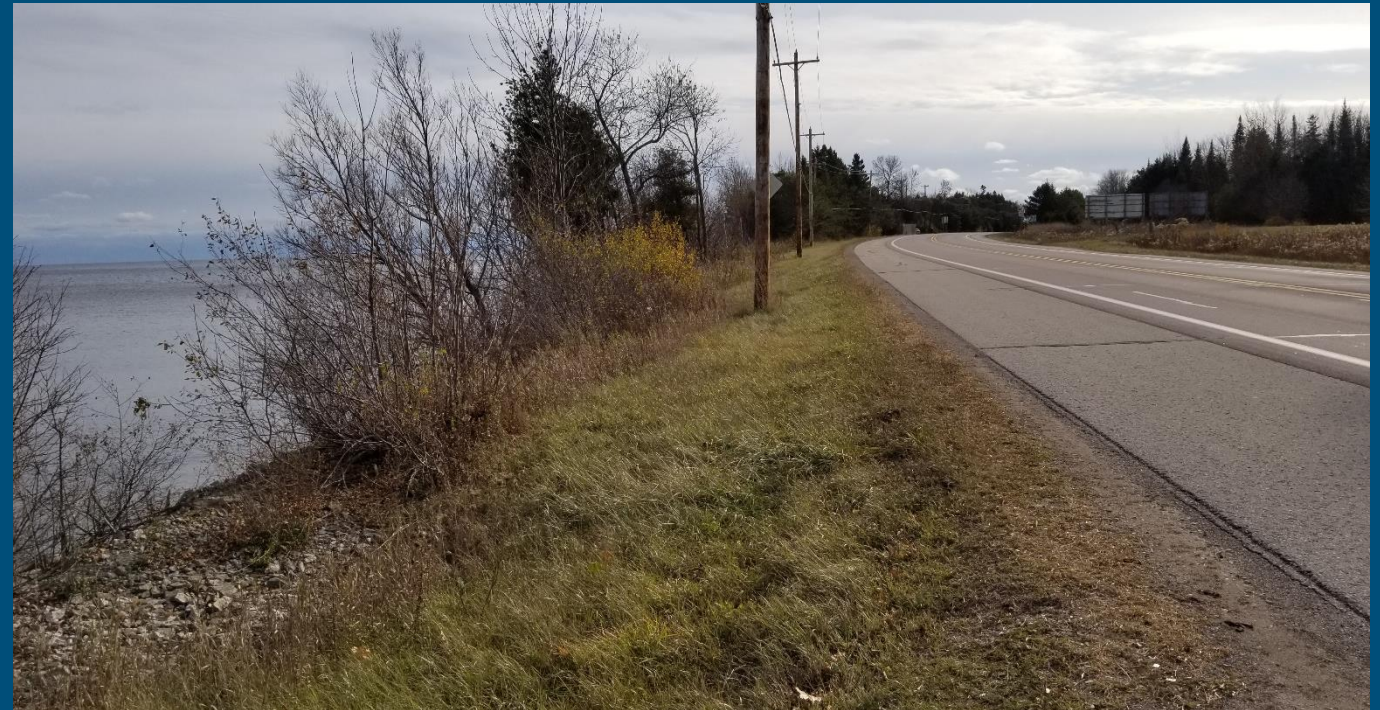
- Driver leaving roadway unlikely to recover, likely to strike fixed object (or water)

- Enclose drainage on SW quad
- Guard rail on bay side (would also discourage photo parking where roadside is eroding into bay)

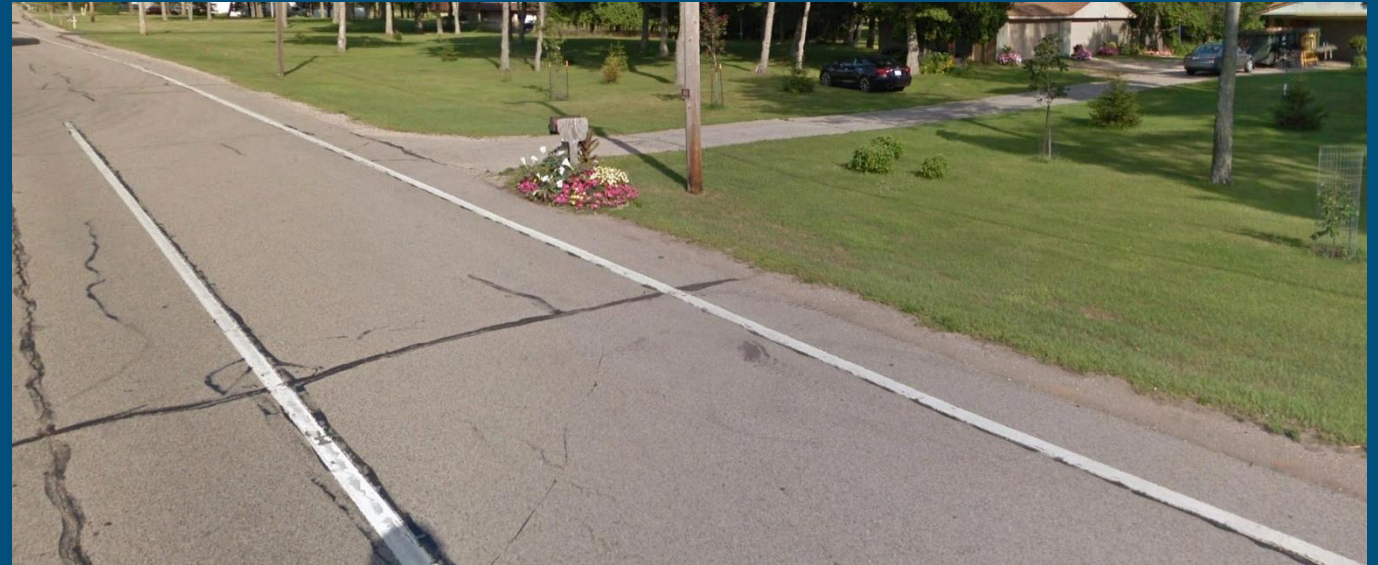
- Sideswipe crashes between vehicles
- Vehicle - ped / bike crash on shoulder

- Install off-road pedestrian facility
- (extend existing sidewalk / path beyond Airport Road)

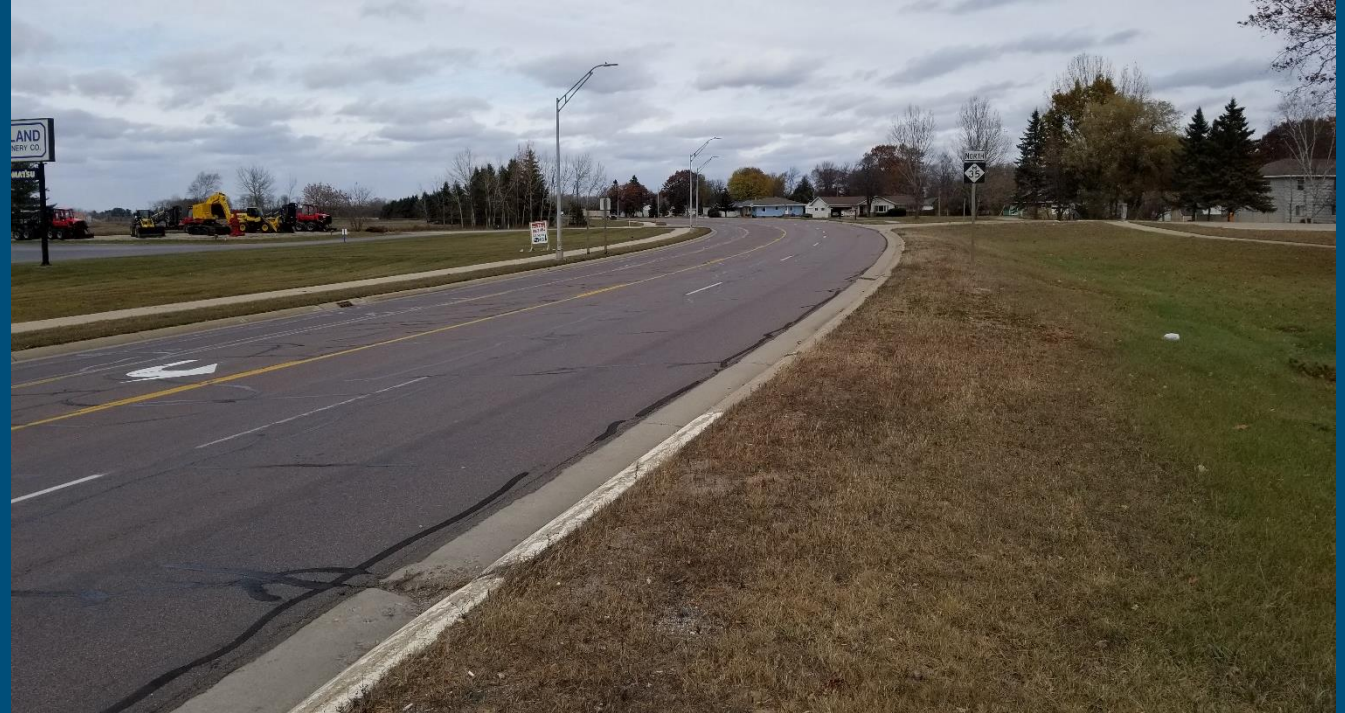
- At higher speed curb may offset drivers towards center lane
- No shoulder for breakdowns
- Curb may disrupt vehicle that departs lane rather than allow for recovery

- Rehab / reconstruct may require design exception
- Monitor speeds in this section w/r/t posted limit
